**Flood Control Project Maintenance
Levee Inspections**

Maintenance Issue Types Only, Levee Inspection Report By Mile - Spring 2018

Sacramento River West Side Levee District

Waterway	Bank	Unit Miles	Inspection Start/End	Inspector
Unit No. 01 Sacramento River	Right	49.64	03/21/2018 03/26/2018	Zach Jojola

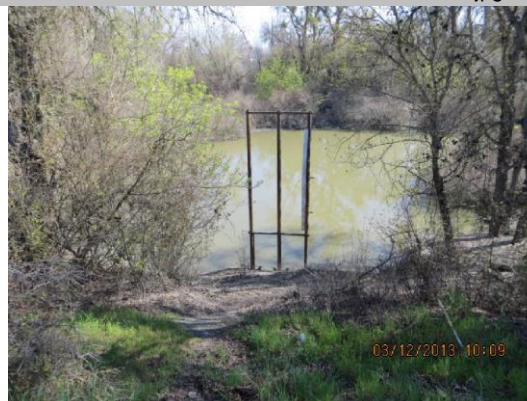
Photo 2 of 3 : UCIP_SP_2018_10085_17226.jpg

FS_ID:10085
DS_ID:20356
EP_NO: N/A
Repair Type: Non-Urgent
Crossing Status: Found
UCIP Comments: Headwall undermined 3-4-feet on WS toe.
FIELD_STRUCT_DESC: 2 of 3: 36-inch steel drainage pipe through the levee, 30 feet below the crown. Flap gate on the waterside (WS) end. 24-inch pipe sleeved through the 36-inch pipe. Annular space between pipes grouted. Pumps inside pump house with a walkway on the landside (LS) toe. [Additional Reference(s): DWR Levee Log, 2006. USACE Sacramento O&M Manual 130, May 1960 (HLM 0.15)].
FS Date: 3/12/2013

Air vents on pipes at WS toe.

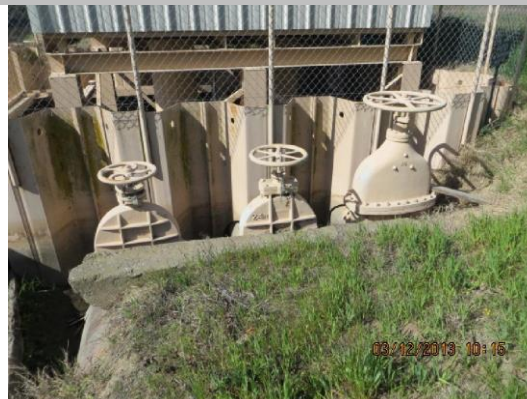
Photo 3 of 3 : UCIP_SP_2018_10085_17225.jpg

Slide gates at pumphouse on LS toe.

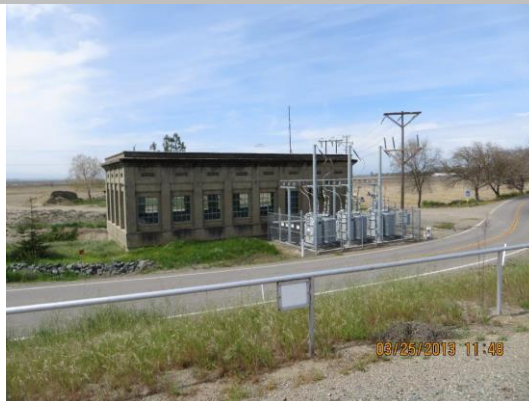
Photo 1 of 3 : UCIP_SP_2018_10146_17312.jpg

Pumphouse on LS toe.

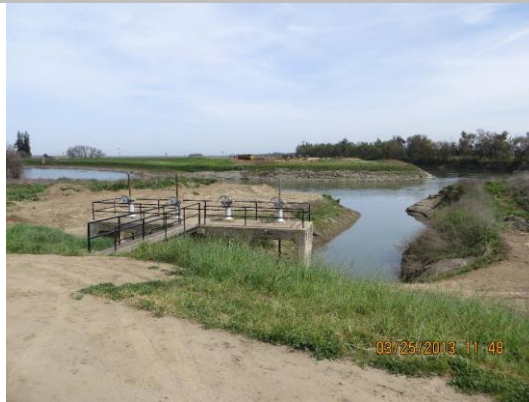
Photo 2 of 3 : UCIP_SP_2018_10146_17311.jpg

Walkway to slide gate actuators on WS shoulder.

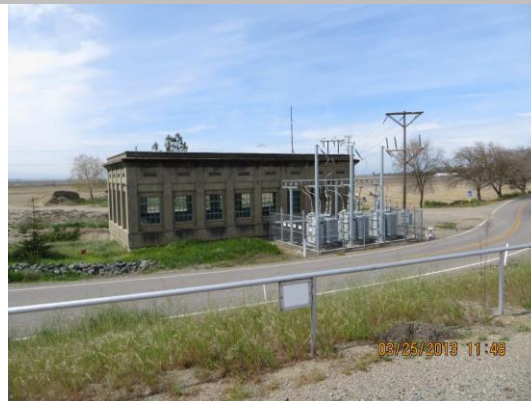
Photo 1 of 3 : UCIP_SP_2018_10147_17316.jpg

Pumphouse on LS toe.

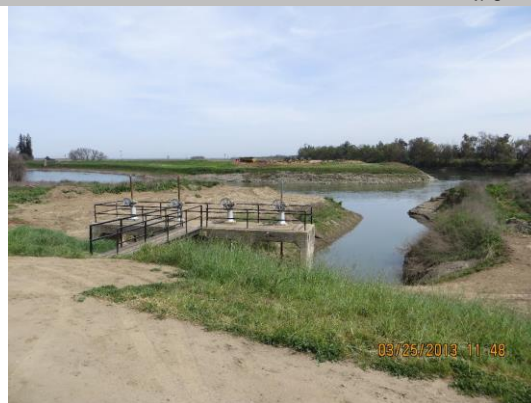
Photo 2 of 3 : UCIP_SP_2018_10147_17315.jpg

Walkway to slide gate actuators on WS shoulder.

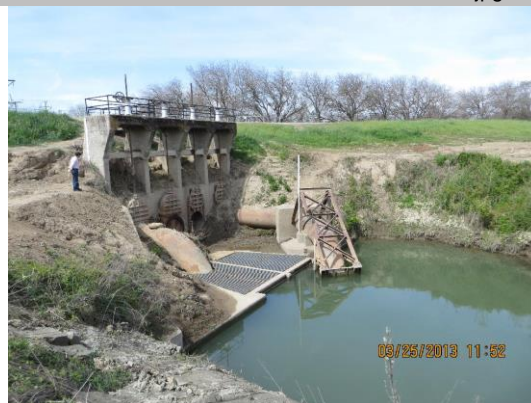
Photo 3 of 3 : UCIP_SP_2018_10147_17314.jpg

Slide gates and pipes at outlet structure on WS toe.

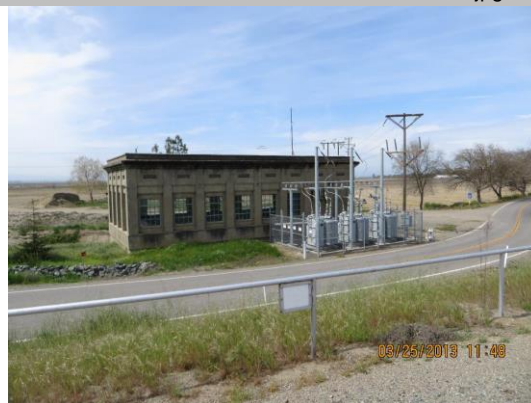
Photo 1 of 3 : UCIP_SP_2018_10148_17320.jpg

Pumphouse on LS.

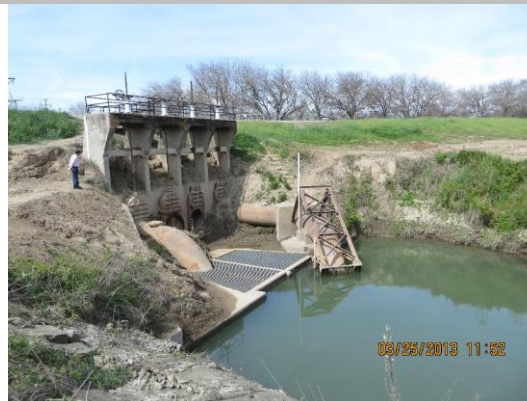
Photo 3 of 3 : UCIP_SP_2018_10148_17318.jpg

Pipes at outlet on WS.

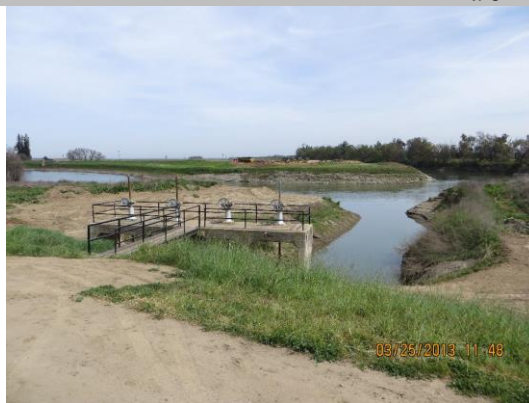
Photo 2 of 3 : UCIP_SP_2018_10149_17323.jpg

Slide gate actuators on platform at WS shoulder.

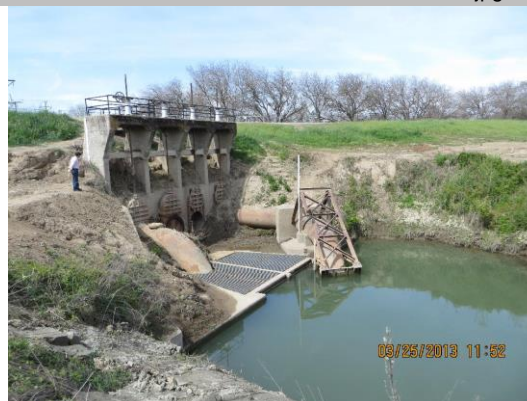
Photo 3 of 3 : UCIP_SP_2018_10149_17322.jpg

Pipes and slide gates at outlet on WS.

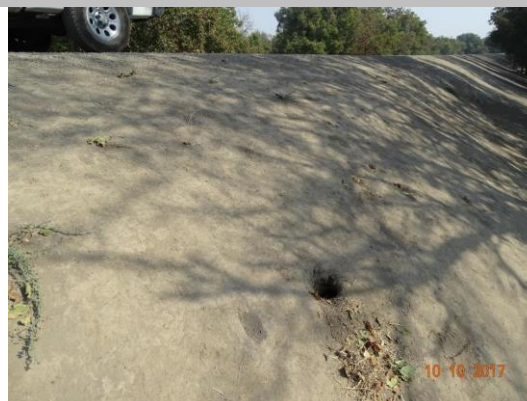
Photo 1 of 2 : SP_2018_NA0016_435_226_20180306_00077.jpg

LM Start	9.62	Rating **	M	Issue No.	226
LM End	9.62	Issue Type +	Ma	Location *	LS
Category	Earthen Levee			GPS Latitude/Longitude	
				Start	End
Item	Animal Control			38.862422 °	38.862422 °
				-121.790305 °	-121.790305 °
DWR ID	DWR_NA0016_01_s_2017_226				
Comment Code					
A3 : No rodents visible, but rodent burrows visible; need to backfill and compact or grout burrows.					
Inspector Comment					
Rodent burrow on landside levee slope.

View of rodent burrow halfway down landside slope. Fall 2017.

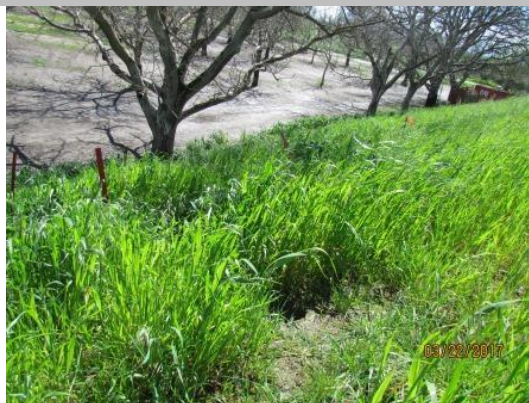
Photo 2 of 2 : SP_2018_NA0016_435_226_20180306_00078.jpg

LM Start	9.62	Rating **	M	Issue No.	226 (cont)	
LM End	9.62	Issue Type +	Ma	Location *	LS	
Category	Earthen Levee			GPS Latitude/Longitude		
				Start		End
Item	Animal Control			38.862422 °		38.862422 °
				-121.790305 °		-121.790305 °
DWR ID	DWR_NA0016_01_s_2017_226					
Comment Code						
A3 : No rodents visible, but rodent burrows visible; need to backfill and compact or grout burrows.						
Inspector Comment						
Rodent burrow on landside levee slope.

Rodent burrow on landside levee slope. Spring 2017.

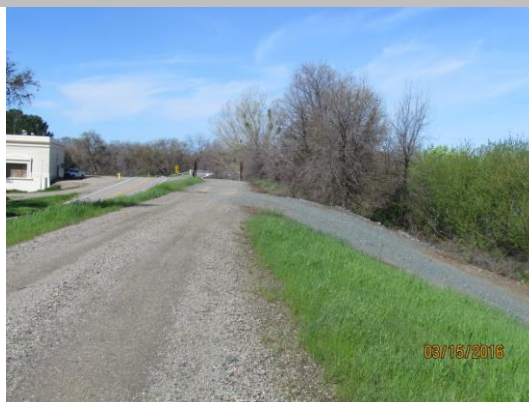
Photo 1 of 2 : SP_2018_NA0016_435_29_20180306_00019.jpg

LM Start	9.68	Rating **	A/W	Issue No.	29
LM End	9.79	Issue Type +	Ma	Location *	WS
Category	Earthen Levee			GPS Latitude/Longitude	
				Start	End
Item	Vegetation			38.862345 °	38.862848 °
				-121.791337 °	-121.793267 °
DWR ID	DWR_NA0016_01_s_2012_29				
Comment Code					
V8 : Environmental Requirements.					
Inspector Comment

View of the revegetation site on the waterward side of the levee looking upstream. Spring 2016.

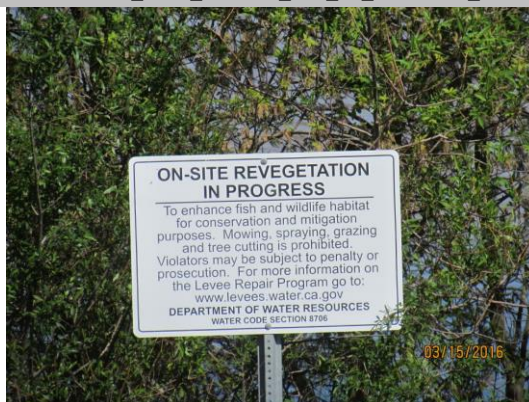
Photo 2 of 2 : SP_2018_NA0016_435_29_20180306_00020.jpg

Revegetation site sign. Spring 2016.

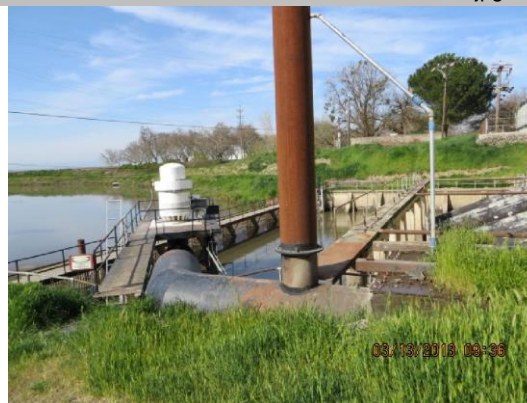
Photo 3 of 3 : UCIP_SP_2018_10163_17340.jpg

Pump on platform at LS toe.

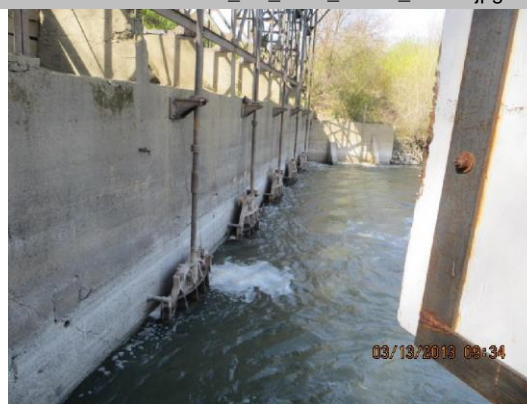
Photo 1 of 3 : UCIP_SP_2018_10164_17345.jpg

Slide gates at concrete headwall at river

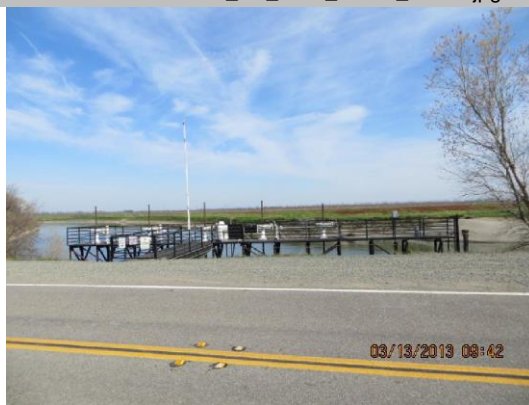
Photo 3 of 3 : UCIP_SP_2018_10164_17343.jpg

Slide gate actuators on WS shoulder.

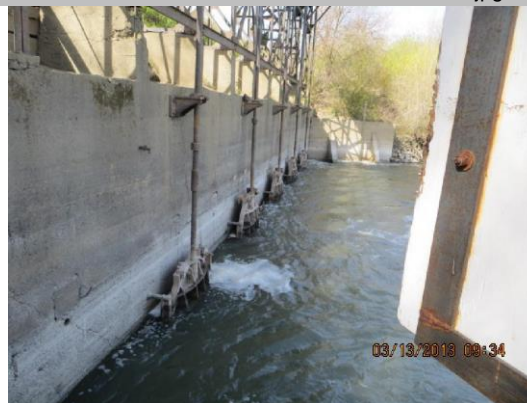
Photo 1 of 3 : UCIP_SP_2018_10165_17348.jpg

Slide gates and headwall on WS toe.

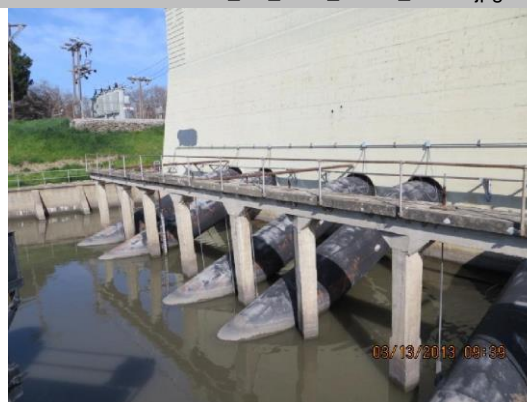
Photo 2 of 3 : UCIP_SP_2018_10165_17347.jpg

Pipes at inlet to pumphouse on LS toe.

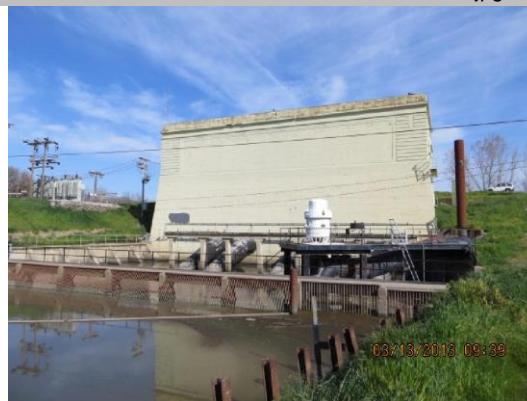
Photo 3 of 3 : UCIP_SP_2018_10165_17346.jpg

Pumphouse on LS.

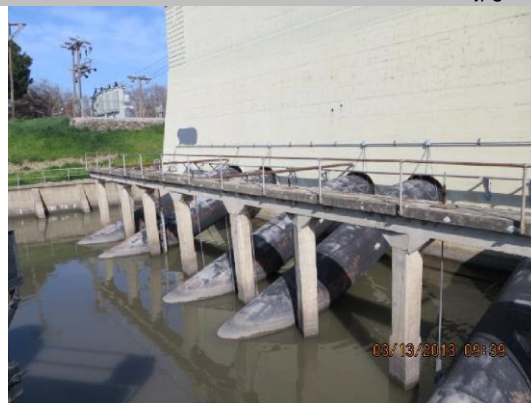
Photo 2 of 3 : UCIP_SP_2018_10168_17359.jpg

Pipe at inlet to pumphouse on LS toe.

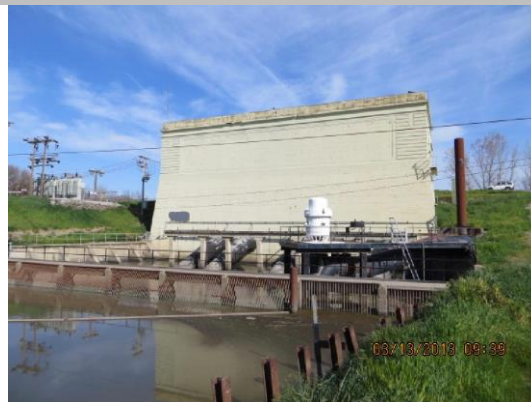
Photo 3 of 3 : UCIP_SP_2018_10168_17358.jpg

Pumphouse on LS.

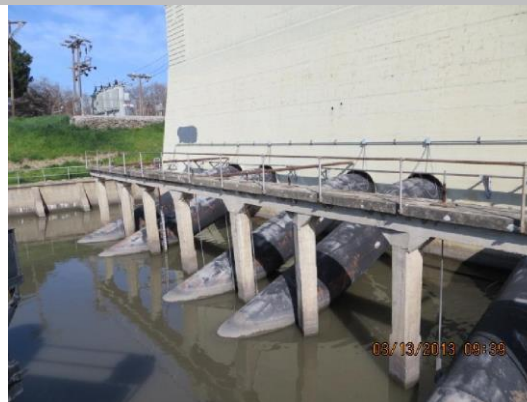
Photo 2 of 3 : UCIP_SP_2018_10167_17351.jpg

Pipes at inlet to pumping plant on LS toe.

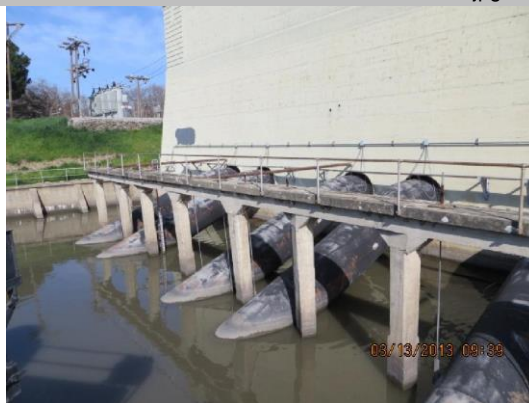
Photo 2 of 3 : UCIP_SP_2018_10169_17363.jpg

pipes at entrance to pumphouse on LS toe.

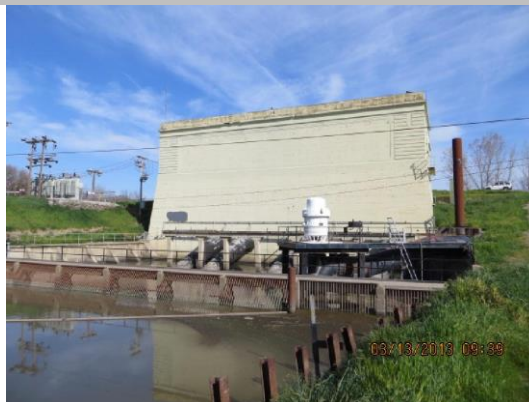
Photo 3 of 3 : UCIP_SP_2018_10169_17362.jpg

Pumphouse on LS.

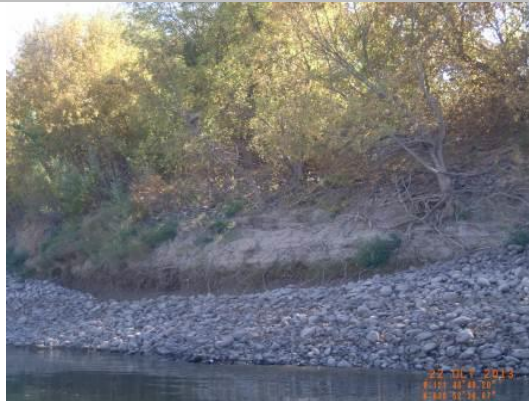
Photo 1 of 1 : SP_2018_NA0016_435_7_20180306_00006.jpg

LM Start	11.50	Rating **	M	Issue No.	7
LM End	11.53	Issue Type +	Ma	Location *	WS
Category	Supplemental			GPS Latitude/Longitude	
				Start	End
Item	2015 USACE Erosion Survey, DRAFT			38.874854 °	38.875109 °
				-121.813018 °	-121.813592 °
DWR ID	DWR_NA0016_01_s _ 2016_7				
Comment Code					
Inspector Comment					
1997 - Toe damage and loss of cobble revetment and small patch of local damage to the cobble revetment. 2000 - Cohesive vertical toe; revegetation site. 2015: No observed changes. [2015 Site ID: SAC_101-3_R]

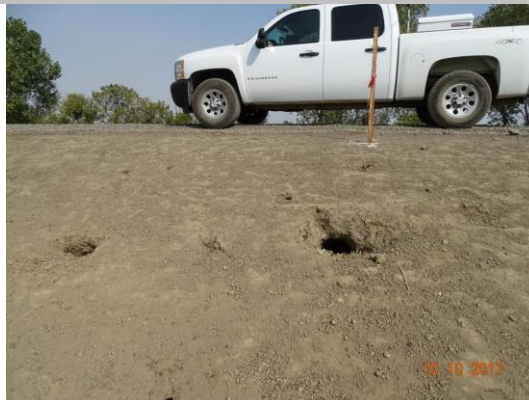
Photo 1 of 2 : SP_2018_NA0016_435_233_20180306_00079.jpg

LM Start	17.64	Rating **	M	Issue No.	233
LM End	17.64	Issue Type +	Ma	Location *	LS
Category	Earthen Levee			GPS Latitude/Longitude	
				Start	End
Item	Animal Control			38.940171 °	38.940171 °
				-121.832771 °	-121.832771 °
DWR ID	DWR_NA0016_01_s _ 2017_233				
Comment Code					
A3 : No rodents visible, but rodent burrows visible; need to backfill and compact or grout burrows.					
Inspector Comment					
Rodent burrows on landside levee slope.

View of additional rodent holes at the same site. Fall 2017.

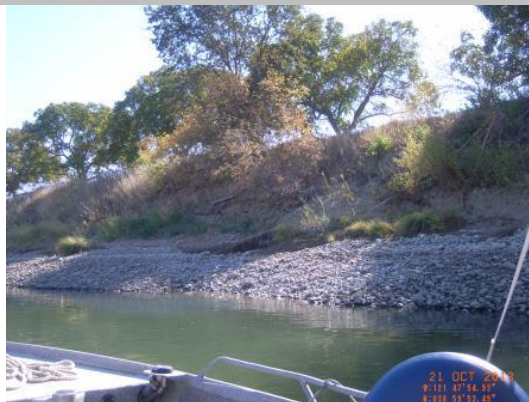
Photo 1 of 1 : SP_2018_NA0016_435_11_20180306_00010.jpg

LM Start	23.55	Rating **	M	Issue No.	11
LM End	23.65	Issue Type +	Ma	Location *	WS
Category	Supplemental			GPS Latitude/Longitude	
				Start	End
Item	2015 USACE Erosion Survey, DRAFT			38.997696 °	38.998336 °
				-121.797584 °	-121.799298 °
DWR ID	DWR_NA0016_01_s_2016_11				
Comment Code					
Inspector Comment					
2008 - Slippage of cobbles off hard underlying toe material. 2011 - Minor slumping site. 2012 - Failing cobble site, site extended upstream. 2015: No observed changes. [2015 Site ID: SAC_115-9_R]

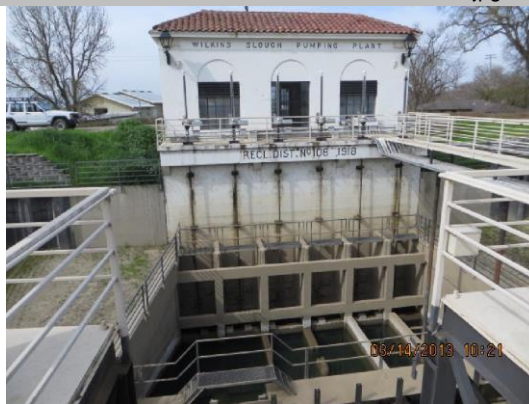
Photo 1 of 3 : UCIP_SP_2018_10271_17501.jpg

Pumphouse on WS shoulder.

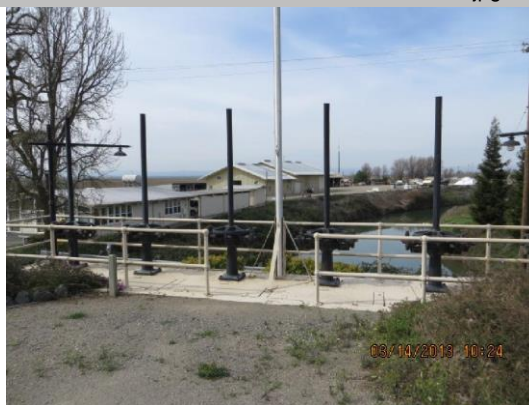
Photo 2 of 3 : UCIP_SP_2018_10271_17500.jpg

Slide gates on LS shoulder.

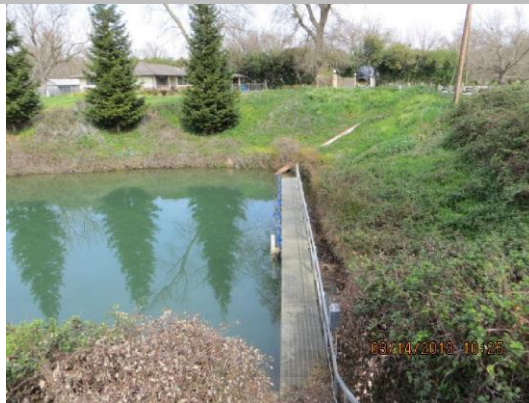
Photo 3 of 3 : UCIP_SP_2018_10271_17499.jpg

Walkway and gates at LS toe.

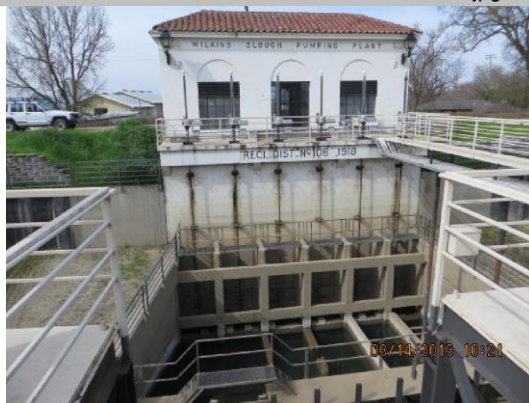
Photo 1 of 3 : UCIP_SP_2018_10284_17530.jpg

Pumphouse on WS shoulder

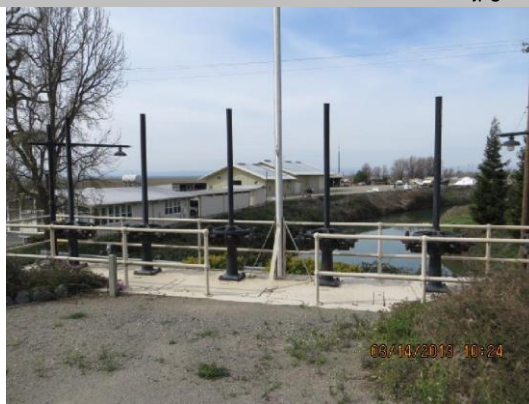
Photo 2 of 3 : UCIP_SP_2018_10284_17529.jpg

Slide gates on LS shoulder.

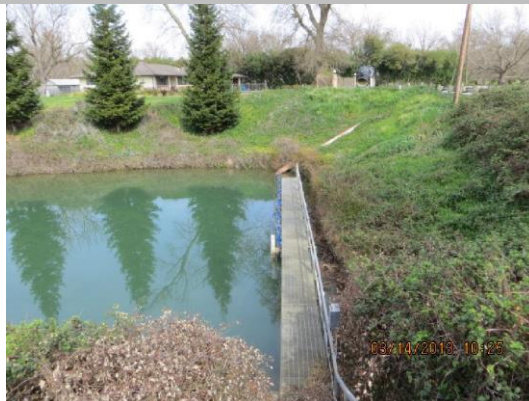
Photo 3 of 3 : UCIP_SP_2018_10284_17528.jpg

Walkway and gates in canal at LS toe.

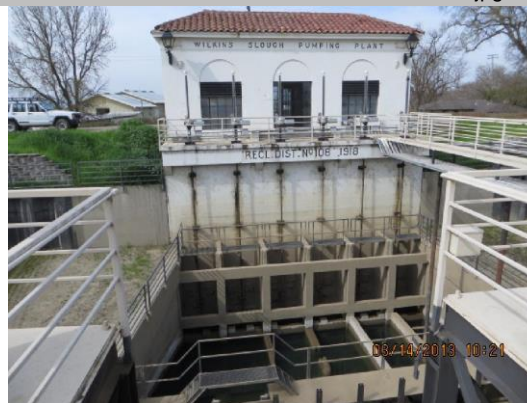
Photo 1 of 3 : UCIP_SP_2018_10273_17504.jpg

Pumphouse on WS shoulder.

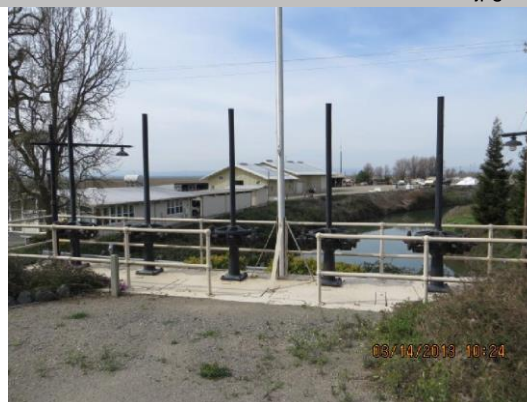
Photo 2 of 3 : UCIP_SP_2018_10273_17503.jpg

Slide gates on LS shoulder

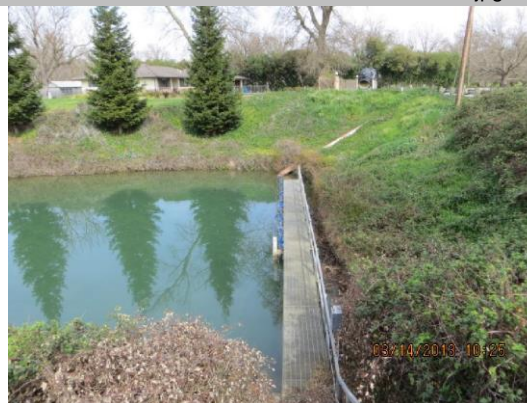
Photo 3 of 3 : UCIP_SP_2018_10273_17502.jpg

Walkway and gates on LS toe.

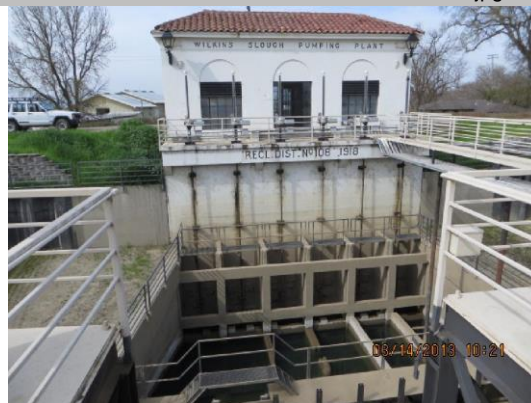
Photo 1 of 3 : UCIP_SP_2018_10278_17519.jpg

Pumphouse on WS shoulder.

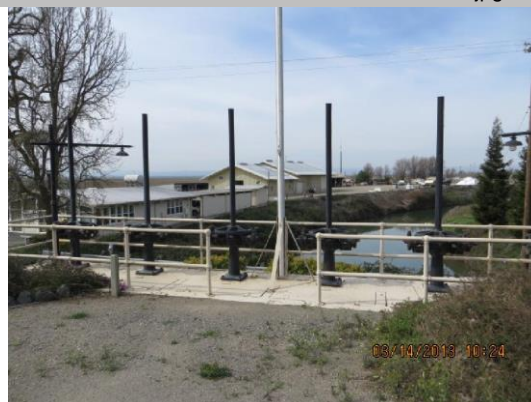
Photo 2 of 3 : UCIP_SP_2018_10278_17518.jpg

Slide gates on LS shoulder.

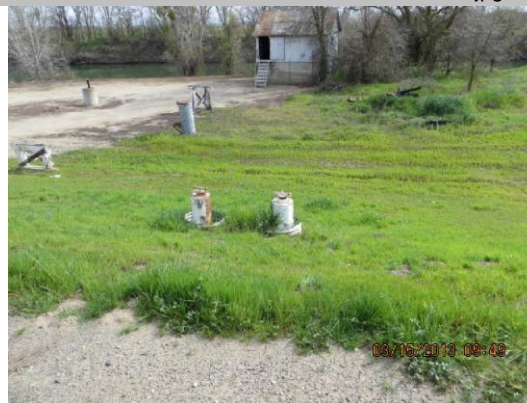
Photo 3 of 3 : UCIP_SP_2018_10306_17564.jpg

siphon breakers in CMP risers on WS slope.

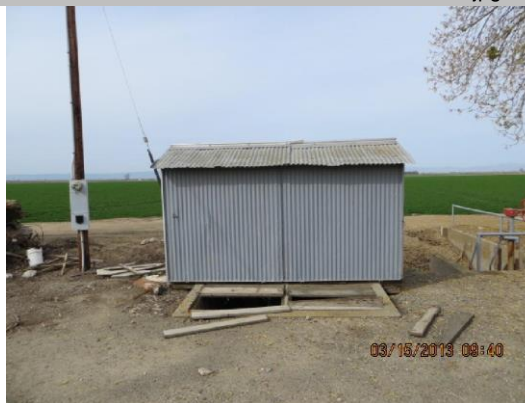
Photo 1 of 3 : UCIP_SP_2018_10307_17569.jpg

Pumphouse over sump on LS toe.

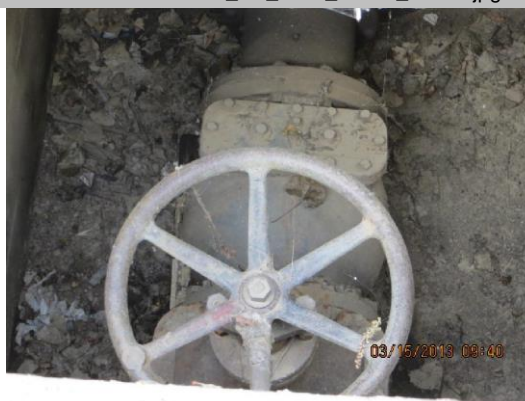
Photo 2 of 3 : UCIP_SP_2018_10307_17568.jpg

Slide gate in concrete vault under pumphouse at LS toe.

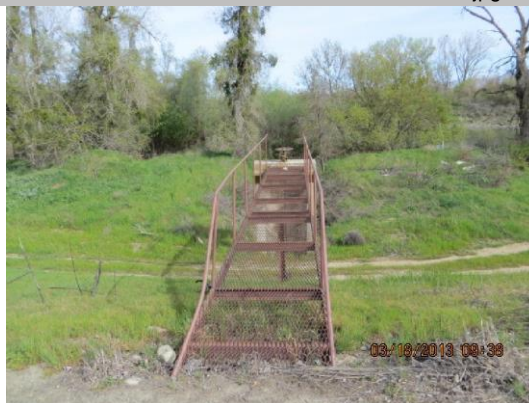
Photo 1 of 3 : UCIP_SP_2018_10406_17666.jpg

Walkway to slidegate on WS berm.

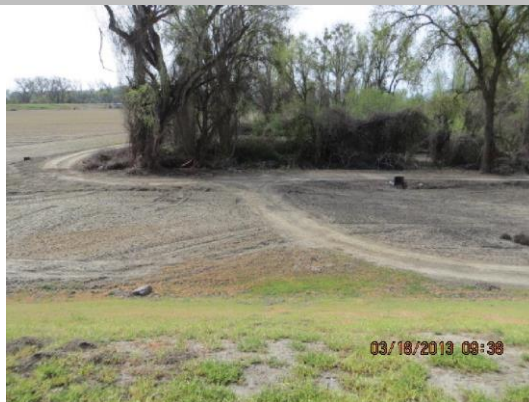
Photo 2 of 3 : UCIP_SP_2018_10406_17665.jpg

Inlet in vegetated area off LS toe.

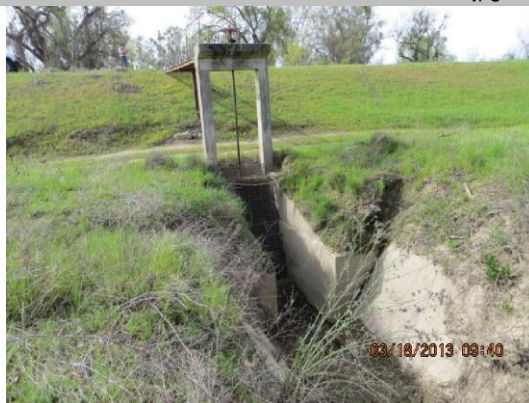
Photo 3 of 3 : UCIP_SP_2018_10406_17664.jpg

Concrete outlet and slide gate at WS toe.

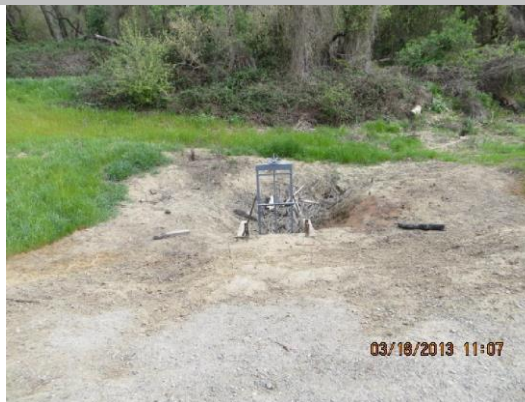
Photo 1 of 3 : UCIP_SP_2018_10426_17705.jpg

Comment Code					
Inspector Comment					
FS_ID:10426 DS_ID:20345 EP_NO: 9374 Repair Type: Non-Urgent Crossing Status: Found UCIP Comments: Verify if pipe is abandoned with landowner and remove or abandon properly if necessary. FIELD_STRUCT_DESC: *ABANDONED* 3 of 3: 24-inch concrete encased steel drainage pipe through the levee, 17 feet below the crown. Slide gate on concrete headwall on waterside (WS) end. Walkway to control gate and gate valve on landside (LS) end. (24-inch pipe [HLM 36.61] authorized under Automatic Board Order (ABO) issued as Permit No. 9374, 1974 - Richard H. Moore). [Additional Reference(s): USACE Sacramento O&M Manual 131, May 1960 (HLM 36.61)]. FS Date: 3/18/2013

Slide gate on WS toe.

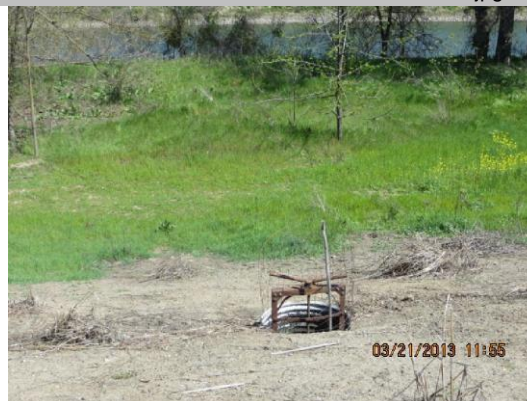
Photo 1 of 3 : UCIP_SP_2018_10535_17877.jpg

FS_ID:10535
DS_ID:20288
EP_NO: N/A
Repair Type: No Action Needed
Crossing Status: Found
UCIP Comments:
FIELD_STRUCT_DESC: 24-inch drainage pipe of an unknown material through the levee, 19 feet below the crown. 6-foot diameter corrugated metal standpipe on the landside (LS) toe. Pump and 24-inch pipe on the LS. Slide gate in corrugated metal riser unit on waterside (WS) slope. Concrete block wall at WS toe for discharge line. (Modified under Permit No. 8587, 1973 - Anthony E. Steidlmayer). [Additional Reference(s): DWR Levee Log, 2006. USACE Sacramento O&M Manual 131, May 1960 (HLM 41.56)].
FS Date: 3/21/2013

Slide gate in CMP riser on WS slope.

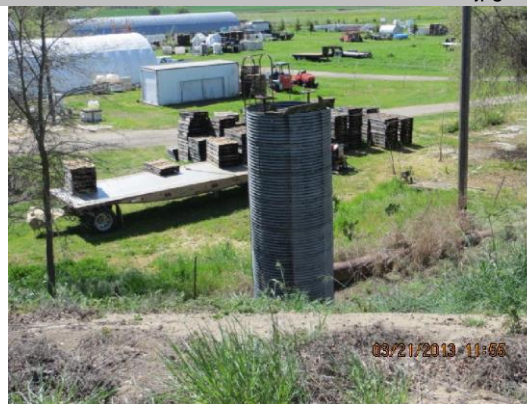
Photo 2 of 3 : UCIP_SP_2018_10535_17876.jpg

6-foot diameter CMP riser with slide gates on LS toe.

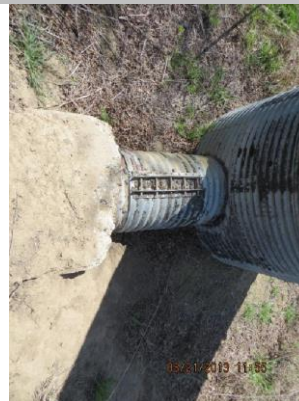
Photo 3 of 3 : UCIP_SP_2018_10535_17875.jpg

Item	DWR UCIP LMA Responsibility			39.152347 °	39.152347 °	
				-121.920610 °	-121.920610 °	
DWR ID						
Comment Code						
Inspector Comment						
FS_ID:10535 DS_ID:20288 EP_NO: N/A Repair Type: No Action Needed Crossing Status: Found UCIP Comments: FIELD_STRUCT_DESC: 24-inch drainage pipe of an unknown material through the levee, 19 feet below the crown. 6-foot diameter corrugated metal standpipe on the landside (LS) toe. Pump and 24-inch pipe on the LS. Slide gate in corrugated metal riser unit on waterside (WS) slope. Concrete block wall at WS toe for discharge line. (Modified under Permit No. 8587, 1973 - Anthony E. Steidlmayer). [Additional Reference(s): DWR Levee Log, 2006. USACE Sacramento O&M Manual 131, May 1960 (HLM 41.56)]. FS Date: 3/21/2013

24-inch CMP at connection to CMP riser on LS toe.

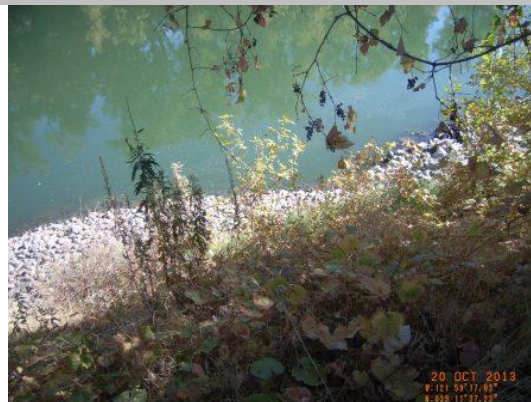
Photo 1 of 1 : SP_2018_NA0016_435_3_20180306_00003.jpg

LM Start	47.62	Rating **	A/W	Issue No.	3
LM End	47.77	Issue Type +	Ma	Location *	WS
Category	Supplemental			GPS Latitude/Longitude	
				Start	End
Item	2015 USACE Erosion Survey, DRAFT			39.193769 °	39.195595 °
				-121.987901 °	-121.988621 °
DWR ID	DWR_NA0016_01_s_2016_3				
Comment Code					
Inspector Comment					
2010 - Old cobble site starting to unravel at toe. 2011 - Cobbles continue to unravel. 2013 - Site extended downstream to revetment. 2015: No observed changes. [2015 Site ID: SAC_141-5_R]

USACE 2013 Photo #1

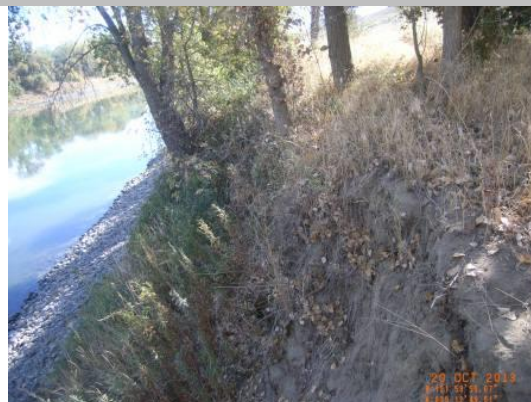
Photo 1 of 1 : SP_2018_NA0016_435_19_20180306_00016.jpg

LM Start	49.46	Rating **	M	Issue No.	19
LM End	49.57	Issue Type +	Ma	Location *	WS
Category	Supplemental			GPS Latitude/Longitude	
				Start	End
Item	2015 USACE Erosion Survey, DRAFT			39.213608 °	39.213869 °
				-121.997543 °	-121.999641 °
DWR ID	DWR_NA0016_01_s_2016_19				
Comment Code					
Inspector Comment					
2011 - Multiple scallops, one tree pop out. Old cobble site starting to unravel at midbank. 2012 - Mid bank slumping continues to worsen but cobble at the toe appears stable. 2015: No observed changes. [2015 Site ID: SAC_143-5_R]

USACE 2013 Photo #1
